Supplementary Materials

1. Dataset statistics

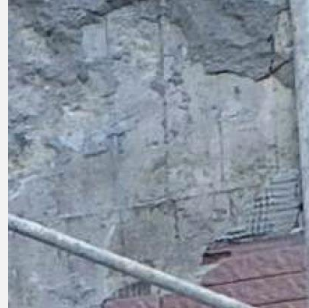
- A. Combined Damage
- B. Flexural
- C. Shear

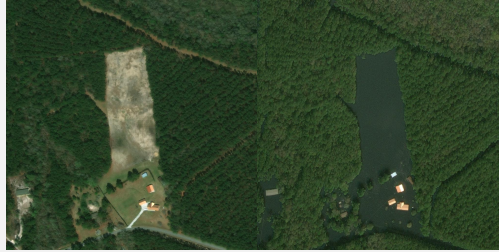
Property Insurance Risk Management
