# dacl10k: Benchmark for Semantic Bridge Damage Segmentation

## – Supplementary Material –

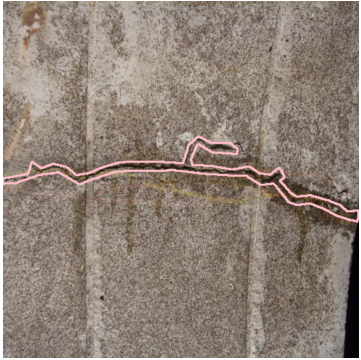
Damage	Visual appearance	Cause	Example
Crack	<ul style="list-style-type: none"> <li>• Elongated and narrow zigzag line</li> <li>• Clearly darker compared to the surrounding area or black</li> </ul>	<ul style="list-style-type: none"> <li>• Concrete's tensile strength is exceeded</li> <li>• Too high bending or shearing load</li> <li>• Settlement of the substructure</li> </ul>

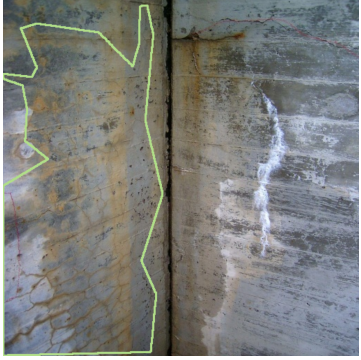
Alligator Crack (ACrack)	<ul style="list-style-type: none"> <li>• Many branched cracks</li> <li>• Mostly arbitrarily orientated</li> <li>• Usually with a small crack width (compared to Crack)</li> </ul>	<ul style="list-style-type: none"> <li>• Inadequate post-treatment or concrete recipe (shrinkage)</li> <li>• Too high temperatures during hardening of the concrete</li> <li>• Formation of expansive phases leading to a volume increase in the concrete as a result of chemical action</li> </ul>

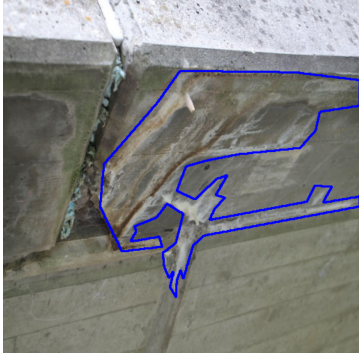
Efflorescence	<ul style="list-style-type: none"> <li>• Mostly roundish areas of white to yellowish or reddish color</li> <li>• Strong efflorescence can look similar to stalactites.</li> <li>• Often appears in weathered (<i>Weathering</i>) or wet areas (<i>WetSpot</i>) of the building and in combination with <i>Crack</i> and/or <i>Rust</i></li> </ul>	<ul style="list-style-type: none"> <li>• Dissolving of salts (calcium, sodium, potassium) from the cement stone or aggregate by humidity changes or water ingress, e.g. constantly running water through the building part or along its surface</li> <li>• The salts consequently carbonate leading to the final visual appearance.</li> <li>• Note: Water ingress can be caused by other defects imposing the draining of water, e.g., <i>Restformwork</i> or damaged <i>Drainage</i>. <i>Efflorescences</i> are also called Calcium leaching.</li> </ul>

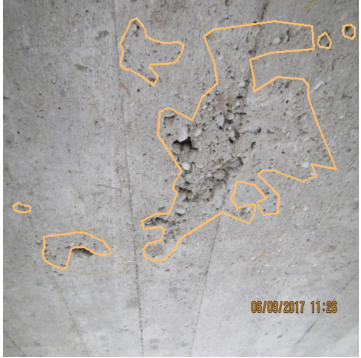
Damage	Visual appearance	Cause	Example
Rockpocket	<ul style="list-style-type: none"> <li>• Visible coarse aggregate</li> <li>• Often in tilts of the formwork and the bottom of building parts (opposite side from which the concrete is poured into the formwork)</li> </ul>	<ul style="list-style-type: none"> <li>• Inadequate rheological properties (viscosity, yield point) of the concrete</li> <li>• Appears due to bad compacting after having poured the concrete into the formwork. Therefore, insufficient deaeration of the concrete follows, causing areas where the cement paste didn't fill the volume between the coarse aggregate completely (<i>Rockpocket</i>).</li> <li>• Note: Hence, the concrete cover of the reinforcement as well as the bond between the bars and the concrete is not provided or reduced. <i>Rockpockets</i> are also called Honeycombing.</li> </ul>

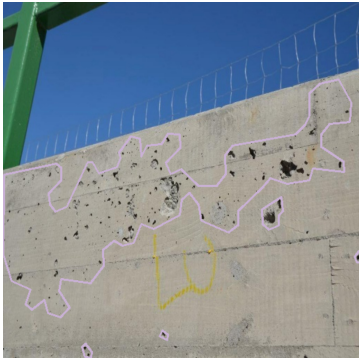
Cavity <sup>1</sup>	<ul style="list-style-type: none"> <li>• Small air voids</li> <li>• Mostly on vertical surfaces</li> </ul>	<ul style="list-style-type: none"> <li>• Inadequate rheological properties (viscosity, yield point) of the concrete</li> <li>• Appears due to bad compacting after having poured the concrete into the formwork. Therefore, insufficient deaeration of the concrete follows causing small "dots" on the surface.</li> <li>• Note: At these spots the concrete cover is reduced. Cavities of usual size have no impact on the building assessment.</li> </ul>

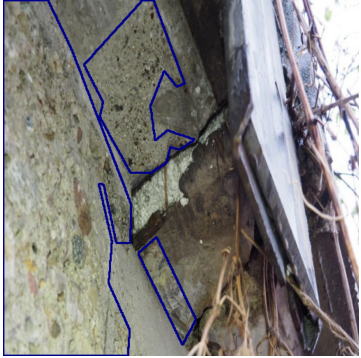
Concrete Corrosion (ConcreteC)	<ul style="list-style-type: none"> <li>• Includes the visually similar defects: Washouts, Concrete corrosion and generally all kinds of planar corrosion/erosion/abrasion of concrete.</li> <li>• Note: We summarize all these "planar corrosion defects" in this class because they are visually hard to differ. According to inspection standards they have to be subdivided which requires strong expertise in building defects.</li> </ul>	<ul style="list-style-type: none"> <li>• Washouts appear on building parts that are constantly in contact with running water leading to the erosion of the concrete, e.g., abutment walls or bridge piers in rivers.</li> <li>• <i>Concrete corrosion</i> can appear as a result of frost-thaw cycles, loss in succession to chemical attacks or abrasion (mechanical or action of acid and salt solutions).</li> <li>• Note: In dacl10k.v1 <i>Concrete Corrosion</i> (ConcreteC) was called "Washouts/Concrete corrosion" (WCconcor).</li> </ul>

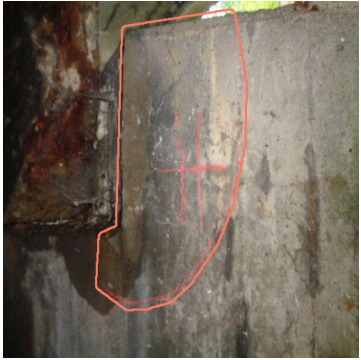
Damage	Visual appearance	Cause	Example
Hollowarea	<ul style="list-style-type: none"> <li>• <i>Hollowareas</i> are not visually recognizable but their markings made with crayons (mostly yellow, red or blue) during close-up/hands-on inspections.</li> <li>• Note: The outer edge of the marking is considered as the boundary of the according area. We annotate every chalk marking that approximately forms a closed geometric figure. Single lines are not labeled as <i>Hollowarea</i> as they are often used for the marking of <i>Cracks</i>.</li> </ul>	<ul style="list-style-type: none"> <li>• Corrosion of the subjacent reinforcement which leads to a volume increase surrounding the reinforcement bar and detaching of the concrete area that covers the bars.</li> <li>• <i>Hollowareas</i> are usually the preliminary stage of <i>Spallings</i> and <i>Exposed Rebars</i>.</li> <li>• Note: Recognizing <i>Hollowareas</i> is very important as the falling concrete parts can cause severe damage. Therefore, hollow sounding areas are usually removed instantly.</li> </ul>

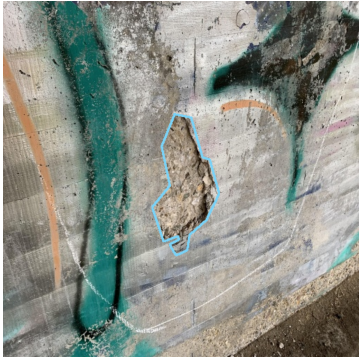
Spalling	<ul style="list-style-type: none"> <li>• Spalled concrete area revealing the coarse aggregate</li> <li>• Significantly rougher surface (texture) inside the <i>Spalling</i> than in the surrounding surface</li> </ul>	<ul style="list-style-type: none"> <li>• Corrosion of the subjacent reinforcement leading to an increase in volume and consequent spalling of the concrete cover</li> <li>• Frost-thaw cycles of intruded water (deeper than <i>Washouts/Concrete corrosion</i>)</li> <li>• Impact from vehicles, damaging during assembly of the building part or removal of the formwork, manufacturing faults</li> </ul>

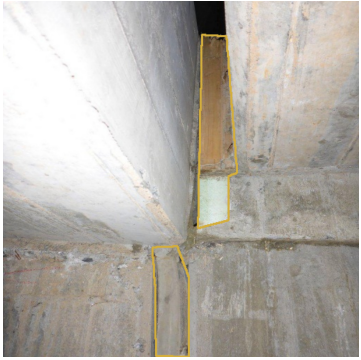
Restformwork	<ul style="list-style-type: none"> <li>• Left pieces of formwork in joints or on the structure's surface</li> <li>• Restformwork can be made of wood and polystyrene (PS).</li> <li>• PS is often used as a placeholder in joints during concreting.</li> </ul>	<ul style="list-style-type: none"> <li>• After the concrete hardening has ended, PS is often forgotten to be removed (e.g., in the joint between the abutment wall and the superstructure).</li> <li>• Note: If <i>Restformwork</i> is not removed, water may be hindered to drain which can lead to other defects (e.g. <i>Spalling, Exposed Rebars, Rust</i>).</li> </ul>

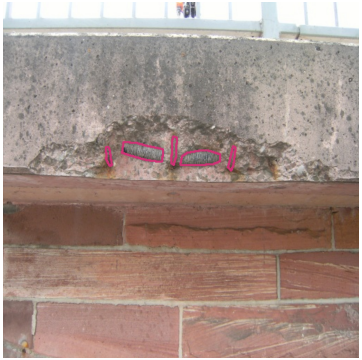
Object	Visual appearance	Functionality	Example
Exposed Re-bars	<ul style="list-style-type: none"> <li>Exposed Reinforcement (non-prestressed and prestressed) and cladding tubes of tendons</li> <li>Often appears in combination with <i>Spalling</i> or <i>Rockpocket</i>, and <i>Rust</i></li> </ul>	<ul style="list-style-type: none"> <li>In reinforced concrete structures, the reinforcement's task concerning the load transfer is to absorb the tensile forces.</li> <li><i>Exposed Rebars</i> occur due to insufficient concrete cover or corrosion and the consequent <i>Spalling</i> of the concrete cover.</li> <li>The reduction of the reinforcement's cross section due to <i>Rust</i> significantly influences the structural integrity of the according building.</li> </ul>

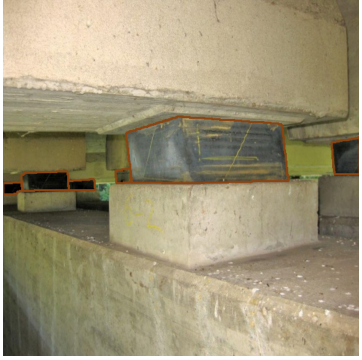
Bearing	<ul style="list-style-type: none"> <li>All kinds of bearings, such as rocker-, elastomer- or spherical-bearings</li> </ul>	<ul style="list-style-type: none"> <li>Bearings transfer the load from the superstructure to the substructure.</li> <li>Note: Bearings can show <i>Rust</i> and <i>Cracks</i> as well as deformation due to settlements in the abutments, overloading or creeping of the bridge. The deformation or damaging of bearings can result in load redistribution which is not considered in the structural design of the bridge.</li> </ul>

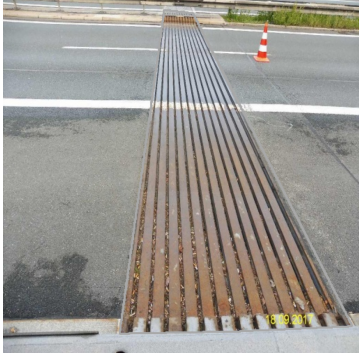
Expansion Joint (EJoint)	<ul style="list-style-type: none"> <li>Located at the beginning and end of the bridge</li> <li>Assembled cross to the longitudinal bridge axis</li> </ul>	<ul style="list-style-type: none"> <li><i>Expansion Joints</i> compensate the thermal longitudinal expansion of the bridge deck and superstructure.</li> <li>Note: Mostly, <i>Expansion Joints</i> are corroded (<i>Rust</i>) and weathered (<i>Weathering</i>) which hinders their ability to compensate the enlargements due to changes in temperature.</li> </ul>

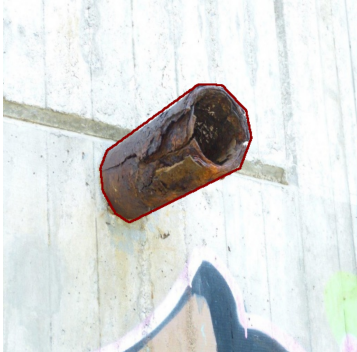
Object	Visual appearance	Functionality	Example
Drainage	<ul style="list-style-type: none"> <li>All kinds of pipes and outlets made of Polyvinylchlorid or metal mounted on the bridge.</li> </ul>	<ul style="list-style-type: none"> <li>The <i>Drainage</i> directs water (often contaminated with deicing salt) away from the bridge.</li> <li>The draining of water is important for the durability of the bridge. If the water can't drain properly, especially when it's contaminated with deicing salts, the bridge's deterioration is accelerated leading to defects, such as <i>Spalling</i>, <i>Exposed Rebars</i> or <i>Rust</i></li> </ul>

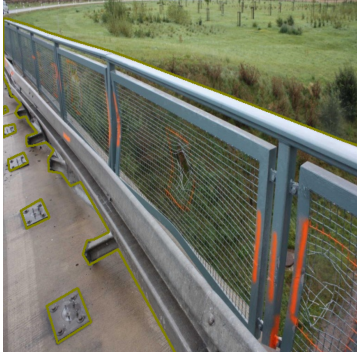
Protective Equipment (PEquipment)	<ul style="list-style-type: none"> <li>Railings, traffic safety features (e.g., steel rail, guide rails, impact attenuation device)</li> </ul>	<ul style="list-style-type: none"> <li>Geometric adequacy and structural capacity of the <i>Protective Equipment</i> is important with respect to the traffic safety.</li> <li>The rail types and installation heights and minimum clearances must be checked.</li> <li>Note: Mostly, they are corroded (<i>Rust</i>) or deformed due to vehicle impact.</li> </ul>

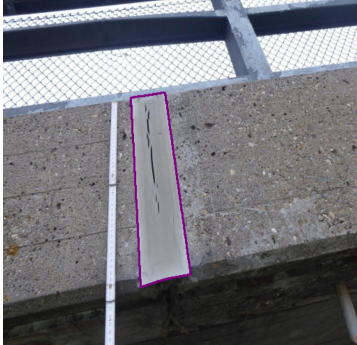
Joint Tape (JTape)	<ul style="list-style-type: none"> <li>All joints that are filled with elastomer or silicon</li> <li>Note: Originally, <i>Joint Tape</i> means an elastomer strap at the end and beginning of relatively small bridges.</li> </ul>	<ul style="list-style-type: none"> <li><i>Joint Tapes</i> compensate longitudinal enlargements due to changes in temperature (like <i>Expansion Joint</i>).</li> <li>Note: A <i>Joint Tape</i> is damaged when it's ruptured or twisted. <i>Joint Tape</i> is also called <i>Bridge Seal</i>.</li> </ul>

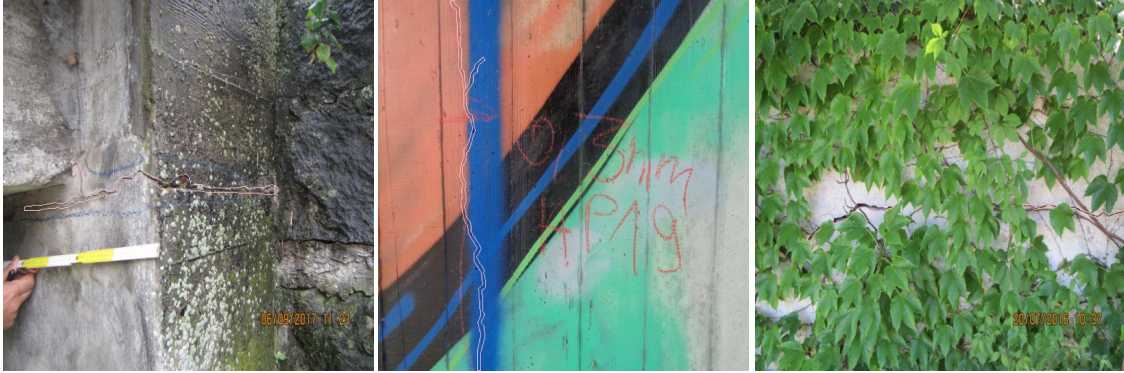
(a) Challenging samples showing a *Crack*: in combination with strong *Weathering*, in combination with *Graffiti* and partially overlapped by vegetation (*Weathering*).

The images in Figure 1a display *Cracks* that are bordered by strongly varying background. The most left image shows an abrupt change regarding the background at the vertical edge of an abutment wall, where one side represents a clean concrete surface and the other is heavily weathered (*Weathering*). On the middle image, the *Crack* traverses different

colors of a *Graffiti*. The most right sample displays vegetation which covers the underlying *Crack*. The two most left images in Figure 1b display defects that can be easily mixed up. *Alligator Cracks* are areas of multiple *Cracks* that are branched and arbitrary orientated, which makes their differentiation complicated. In the most left image, both of these classes are present. As mentioned in the main paper, differentiating between *Weathering* and *Wetspot* is problematic because they often overlap with each other (see middle image in Figure 1b). Another problematic class is *Restformwork* which is under the lower five classes regarding the achieved IoU by our best model. In the most right image of Figure 1b *Restformwork* is covered by concrete slurry. Furthermore, *Restformwork* can be made of wood and the color of the polystyrene may vary. Thus, this class has many different visual appearances, which the model has to learn to summarize in one damage class. In Figure 1c, we display the three classes of dacl10k which are the most complicated to differ: *Spalling*, *Rockpocket* and *Washouts/Concrete corrosion*. While they look very similar, their cause and assessment differ decisively (see Table 3).

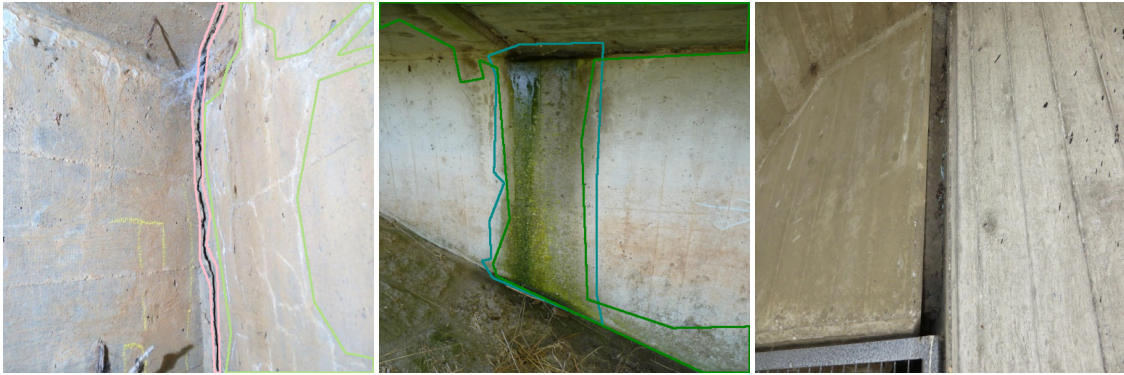
(b) *Crack* vs. *Alligator Crack*, *Weathering* vs. *Wetspot*, *Restformwork* covered with concrete slurry (no ground-truth annotation for better visibility).

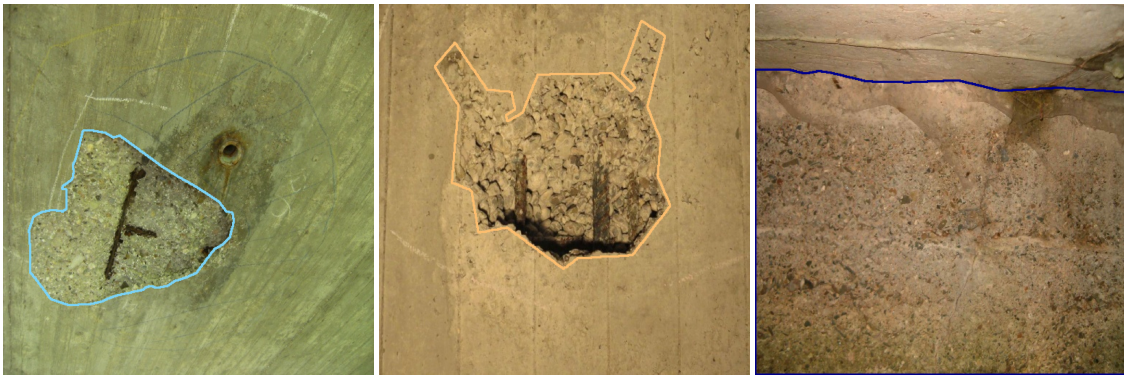
(c) *Spalling*, *Rockpocket*, *Washouts/Concrete corrosion*.

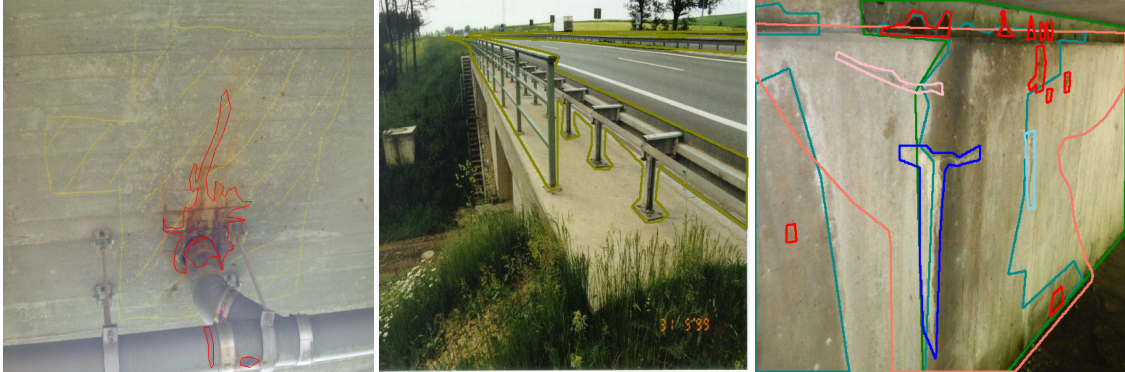
(a) No clear border of the defect (*Rust*), the class (*Protective Equipment*) is stretched from fore- to background. Many overlapping classes with partially low contrast like the border and hatching of the *Hollowarea* (pale red), and the *Efflorescence* (dark blue) next to the bright, dry and healthy concrete surface.

Figure 2 includes images representing class-independent difficulties (not exclusively for one class) and image quality problems across the dataset. Often, defects show no clear border, leading to inconsistent annotations and predictions. This “smearing of damage borders” can be observed for *Efflorescence*, *Weathering*, *Wetspot* and *Rust*. An example of the latter is shown in the most left image tile of Figure 2a. In addition, objects and defects can reach from the foreground to the background (see middle image in Figure 2a), and some defects may show weak differences to their surrounding area due to low contrast (see most right image in Figure 2a). Further problems concern the image quality, such as lens flares, partial overexposure due to the usage of flashlight or reflections (see Figure 2b).

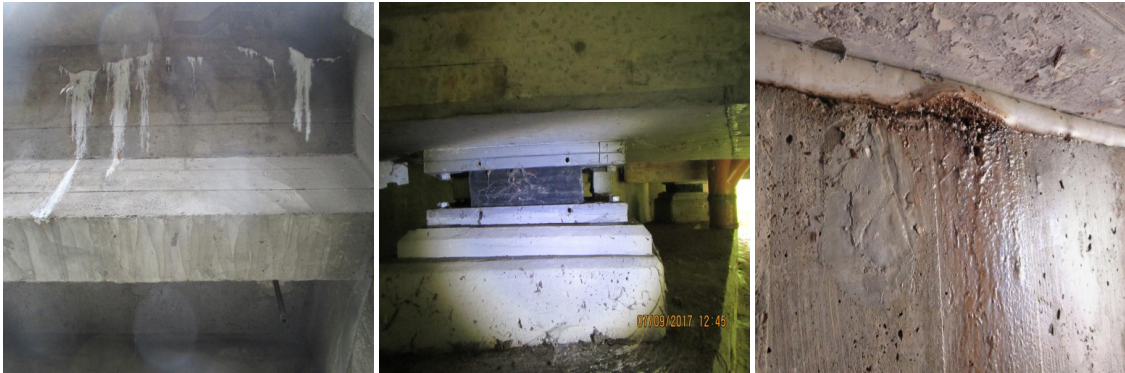
(b) Image quality problems: lens flares, partial overexposures due to flashlight, and sunlight.
